**Gall Thomson Connector Release
Hawaii Single Point Mooring Terminal
May 19, 2006**

**Tesoro Corporation
300 Concord Plaza
San Antonio, TX 78216**

August 30, 2008

**Berkeley Engineering And Research, Inc.
2216 5th Street
Berkeley, CA 94710
(510) 549-3300
(510) 549-3395 fax**

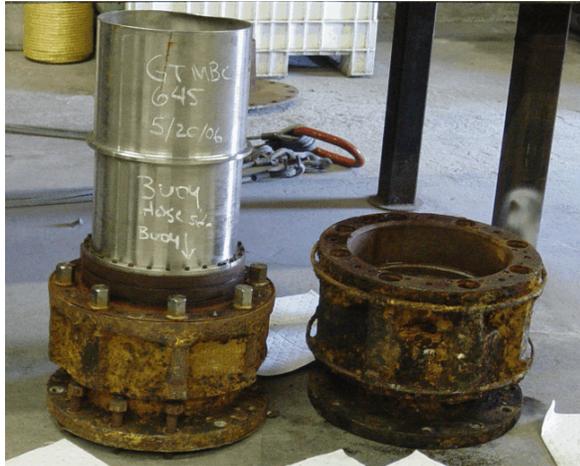
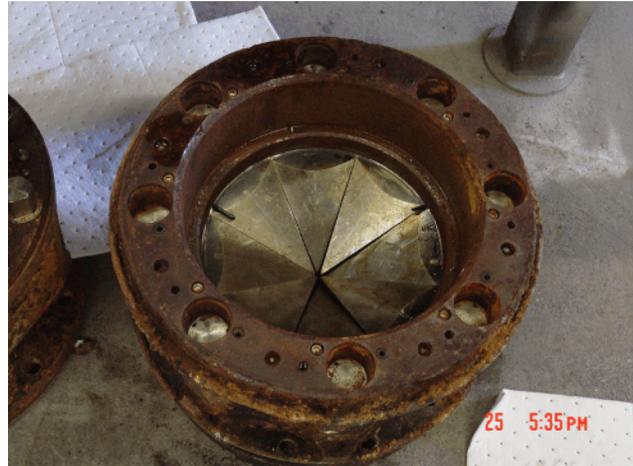
The subject GTC, GT0645, is shown below in Figures 6 and 7 while still in Hawaii. The breakway flange in the center of the unit had come apart or released. There is a shutoff valve in each half of the unit to minimize the loss of hydrocarbons into the ocean. One of the shutoff valves can be seen in Figure 6; it consists of 8 triangular-shaped sections, or fingers, that rotate toward the center and create a seal. The silver-colored, stainless steel sleeve, visible in Figure 6a, holds open the spring-loaded shutoff valve fingers when the GTC is in normal operation.

Figure 6a and 6b. The subject GTC in Hawaii. Both halves are shown in 6a. The shutoff valve in the ship end of the GTC can be seen in 6b.

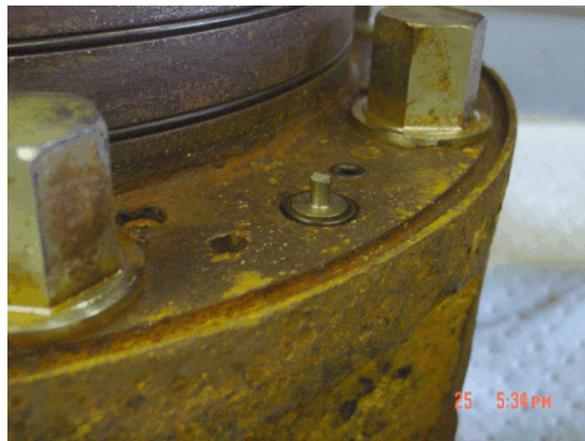
The two halves of the GTC are held together with 8 titanium breakaway studs. The studs have a diameter of 5/8 inches on each end. The middle section is ground down to approximately 1/4 inch in diameter (see Figures 2 and 7) so that the stud will breakaway at the design load.

Figure 7. Closeup of a broken breakaway stud (center of picture) in the subject GTC.

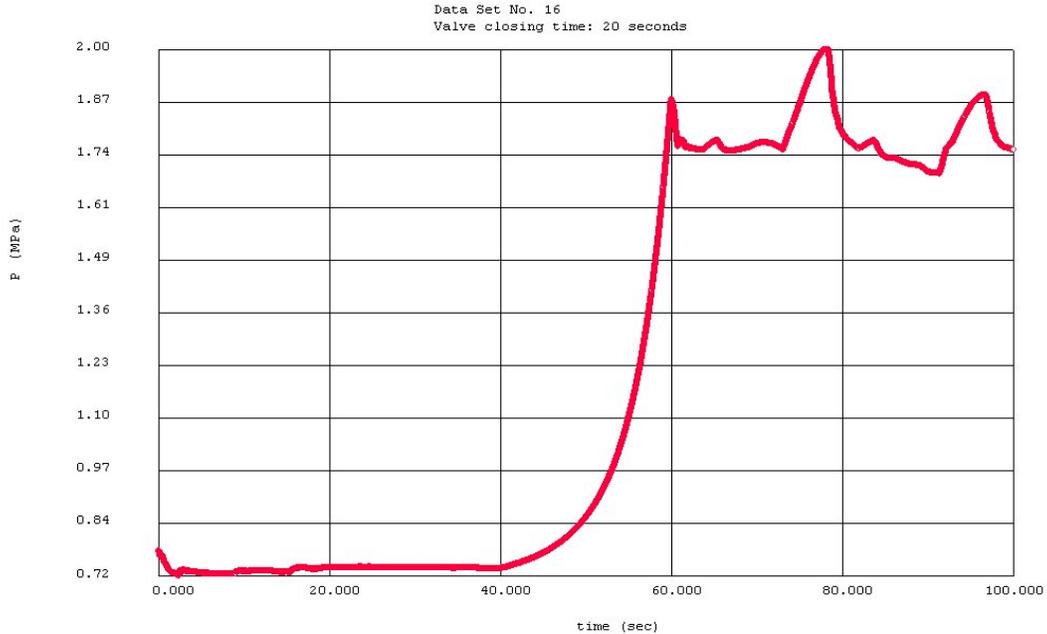
Figure 10. Pressure transient at the GTC for a 20 second onshore terminal MOV close time.

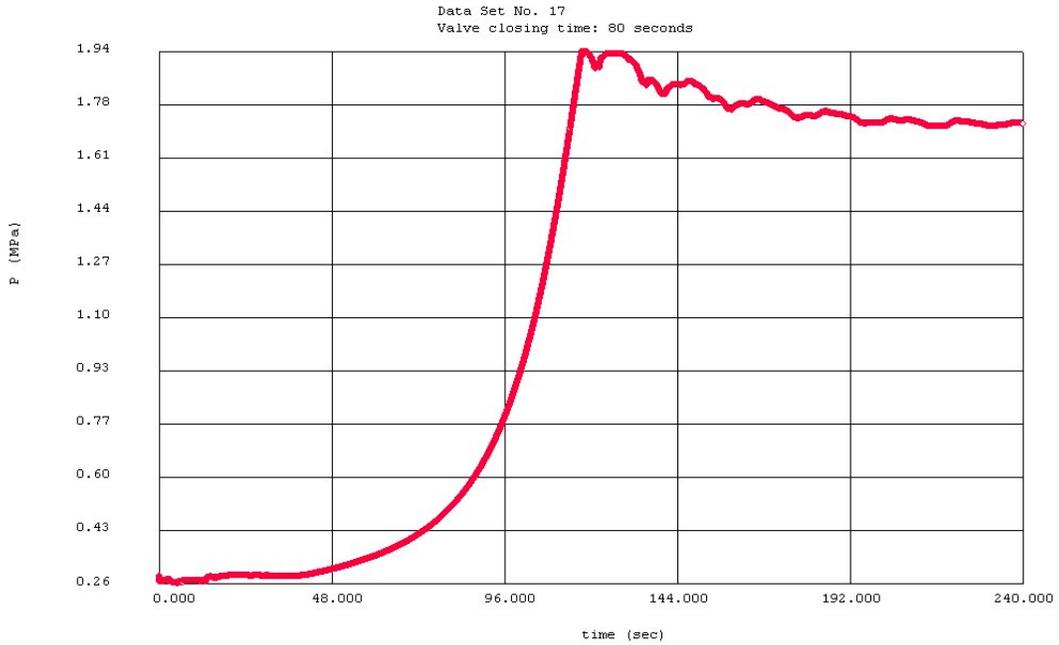
Figure 11. Pressure transient at the GTC for a 80 second onshore terminal MOV close time.

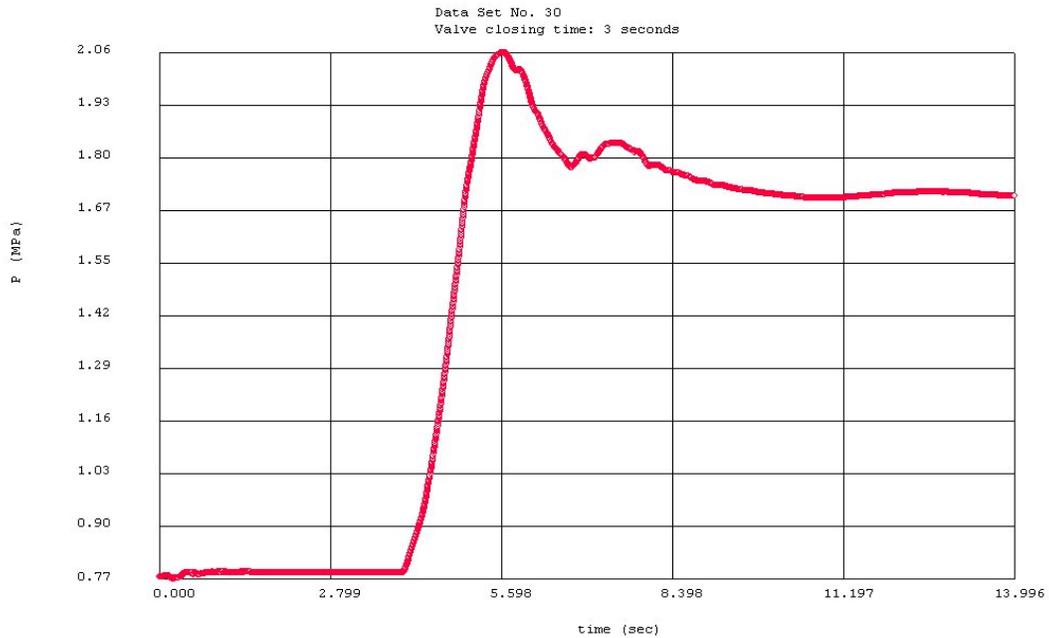
The minimum close time for the onshore MOV is 20 seconds. The hydraulic transient for 3 second closure at the GTC was also calculated (see Figure 12). The shut off valves in the GTC were set by Gall Thomson to close in 3 seconds.

Figure 12. Pressure transient at the GTC for a 3 second GTC valve close time.

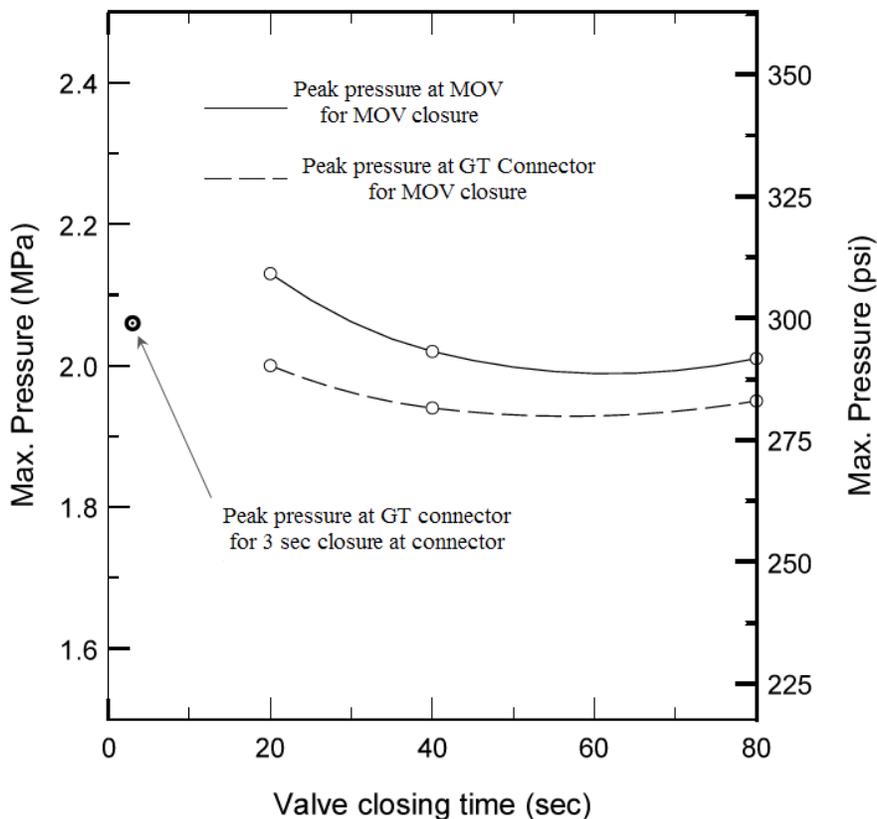
A summary of the results are shown in Figure 13 below. Peak pressure at the GTC and onshore MOV are given as a function of valve close time (solid and dashed lines in Figure 12). The peak pressure at the GTC was also calculated for a 3 second close time at the GTC (circle with a dot in center). None of the calculated pressures are near the 450 psi necessary to cause a connector release. It should be noted that the pressures experienced at the ship would be lower than the values presented in Figure 12.

Figure 13. Hydraulic transient peak pressure results. Peak pressure for closure at the GTC connector in 3 seconds (single point). Peak pressure at the terminal MOV (solid line) and at the GTC connector (dashed line) as a function of MOV closure time.

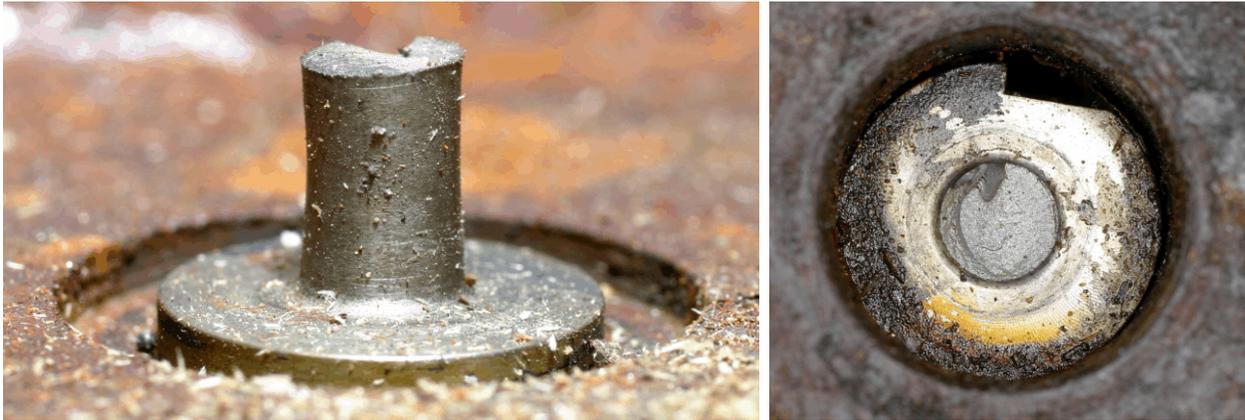
Figure 14a and 14b. Breakstud #3 fractured through the radius at the end of the reduced section.

Breakstud #3 is shown in Figure 14. Note the visible grinding scratches (Figure 14a) and the flat fatigue fracture surface and ratchet marks (initiation sites) from the 1 to 4 o'clock position. Surface grind marks in the fatigue damaged breakstuds are on the order of 60-80 micro-inches (millionths of an inch). Grind marks this deep can significantly reduce the fatigue strength of titanium alloys. Data presented in Reference [5] indicates that a surface roughness of this magnitude can decrease the fatigue strength of titanium alloys by more than a factor of 4. Most fatigue critical locations in titanium aircraft components are shot peened for this reason. The combination of high local stresses due to a small radius, a rough grinding process and a scratch sensitive material results in a very fatigue sensitive surface as shown in Figure 15.

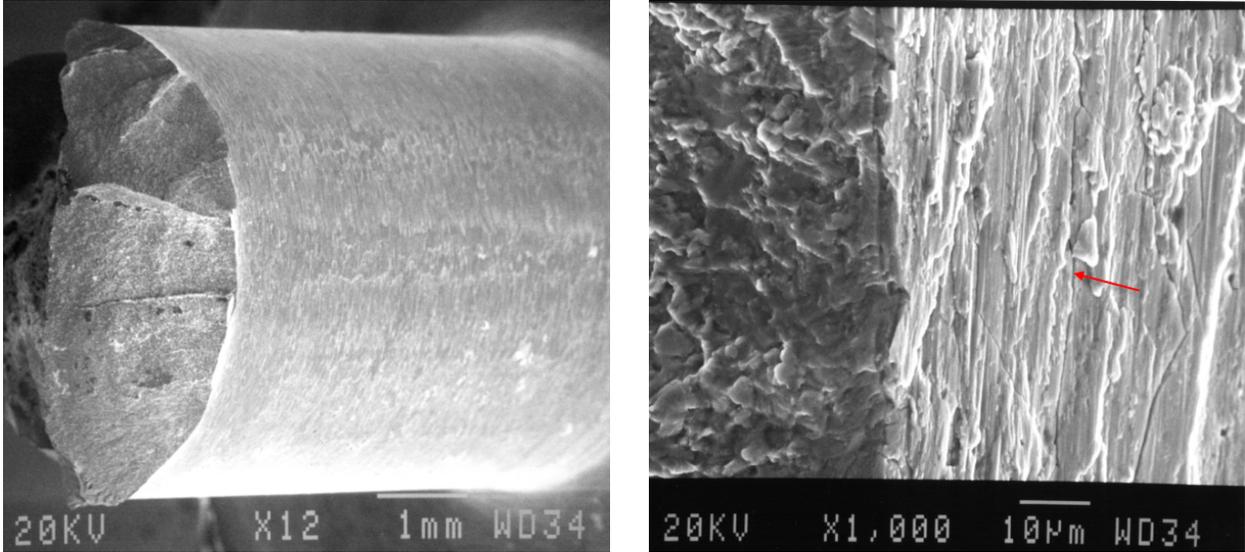
Figure 15a and 15b. Smeared metal on breakstud #1 reduced section surface from grinding (left). Grinding marks and secondary cracks (red arrow) on breakstud #3 surface (right).

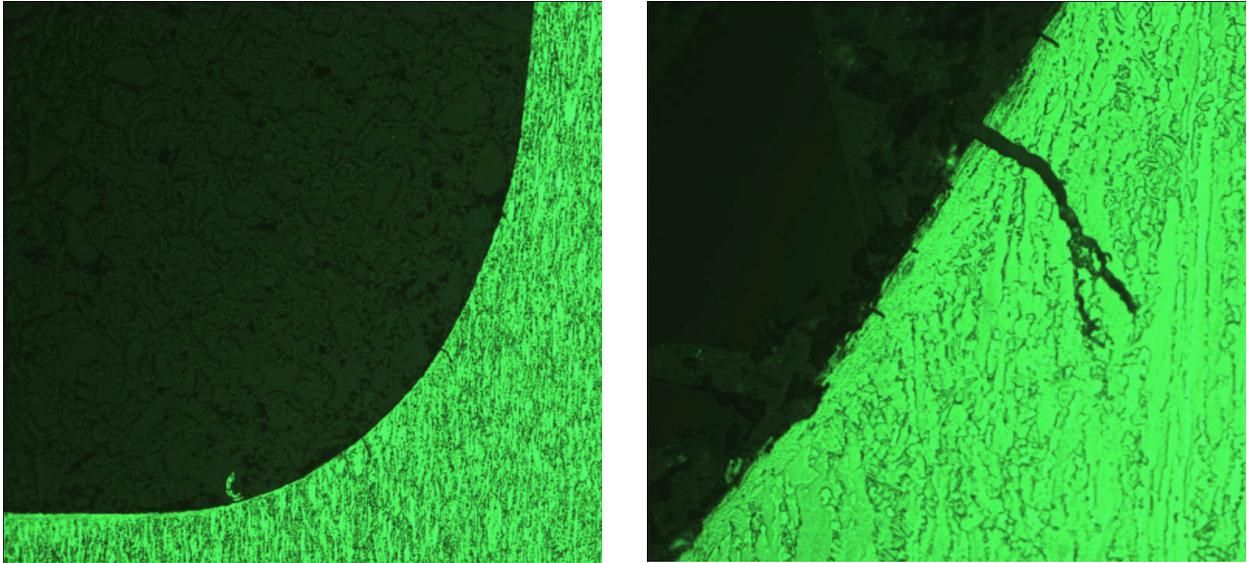
Sectioning breakstuds #8 and #2 reveals a work-hardened surface layer due to the grinding manufacturing process as shown in Figures 16 and 17 below.

Figure 16a and 16b. Cracks in #8 breakstud radii that did not fracture through. Magnification is 50x on the left and 500x on the right. Note, the work hardened layer with numerous cracks.

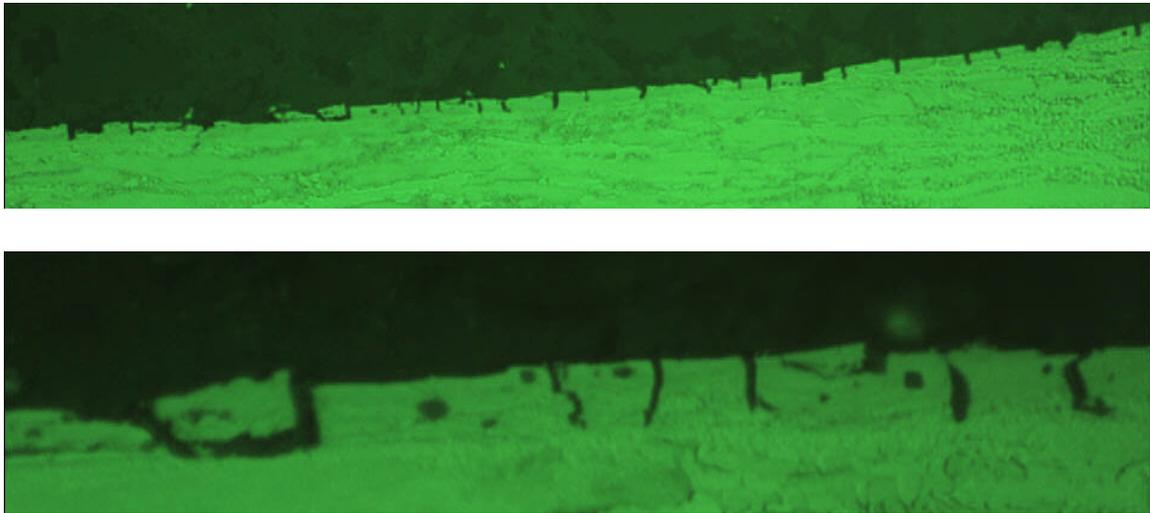
Figure 17a and 17b. Cracks in #2 breakstud reduced section. Magnification is 200x on the left and 1000x on the right. Note, the work hardened layer with numerous cracks. Breakstud #2 failed by overload.

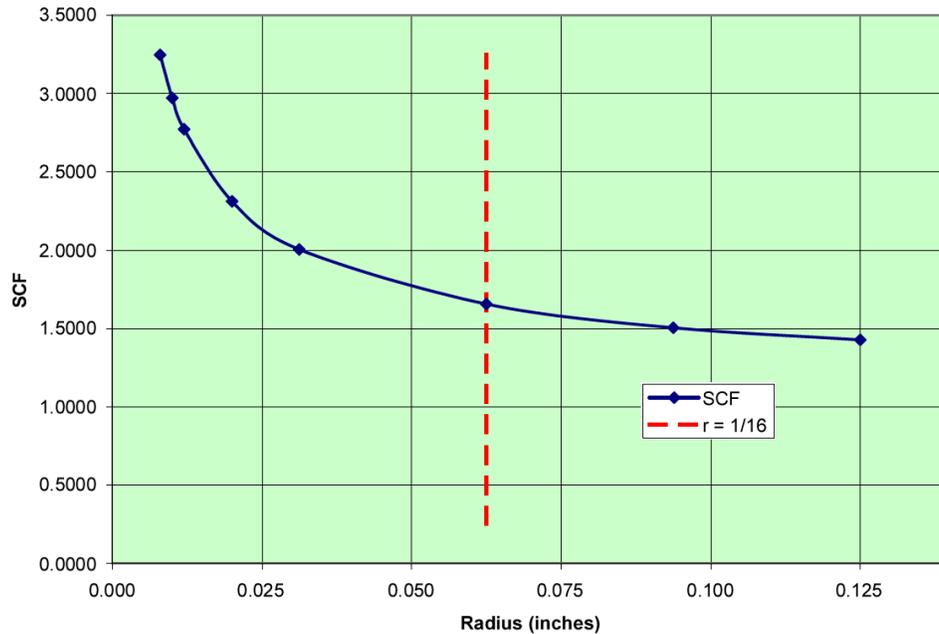
The radius at each end of the reduced section causes a local stress increase that can be characterized by a stress concentration factor (SCF). The SCF is a multiplicative factor; the nominal stress in the reduced section multiplied by the SCF gives the peak local stress in the radius. They can be calculated using formulas given in Reference [12]. For the minimum radius, 10 mils, found in the exemplar breakstuds, the SCF is approximately 3.0 as shown in Figure 19. The local peak stress in the radius is approximately 3 x higher than the nominal stress in the reduced section.

Figure 19. SCF as a function of radius dimension in the breakstud reduced section.

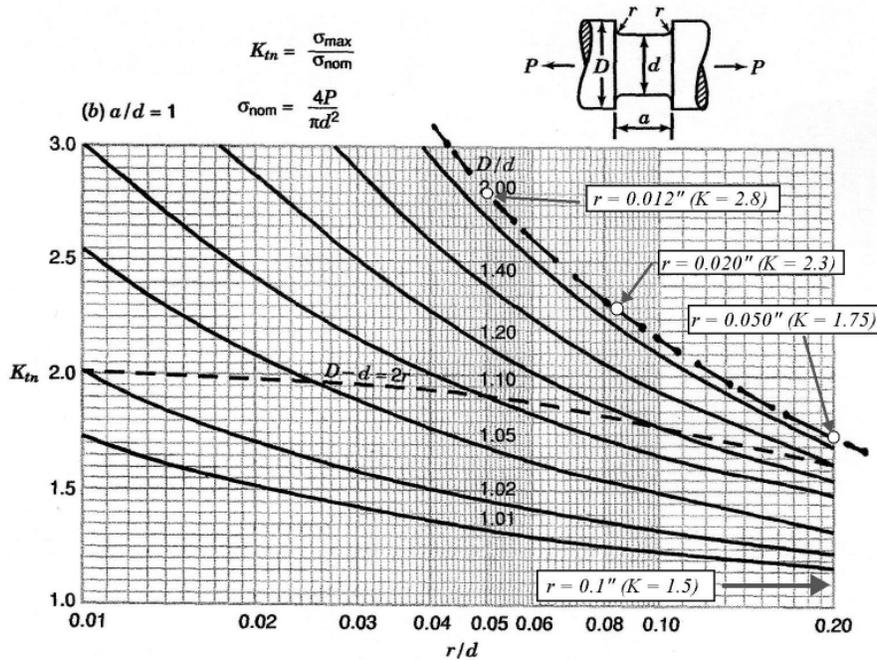
Note, that requiring all radii to be no less than 1/16 inches reduces the peak stress by almost a factor of 2, relative to the minimum measured radii. Plotting the same results on the SCF design graph shown in Figure 20, indicates that the subject SCF range for the current breakstud (drawn in dashed line) is above and to the right of the given published design data (solid lines); this should serve as a red flag to any designer.

Figure 20. SCF data for the breakstud plotted against design data [13].
