**Gall Thomson Connector Release
Hawaii Single Point Mooring Terminal
May 19, 2006**

**Tesoro Corporation
300 Concord Plaza
San Antonio, TX 78216**

August 30, 2008

**Berkeley Engineering And Research, Inc.
2216 5th Street
Berkeley, CA 94710
(510) 549-3300
(510) 549-3395 fax**

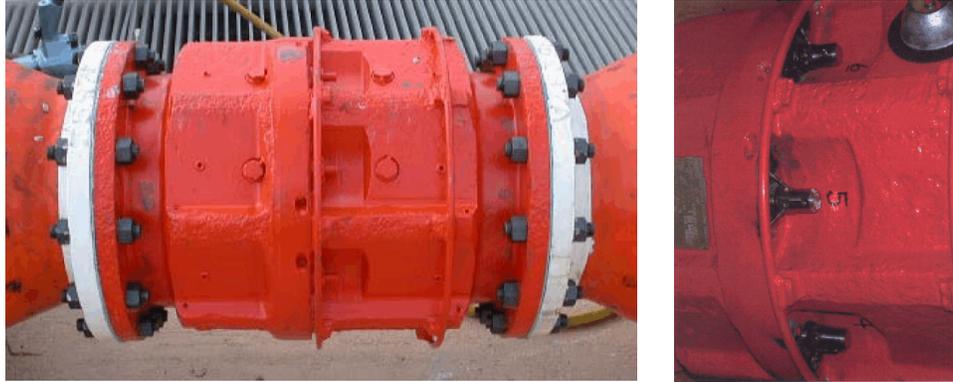
Figures 2a and 2b. Gall Thomson breakaway in a hose string on left and closeup of installed breakaway studs on the right.

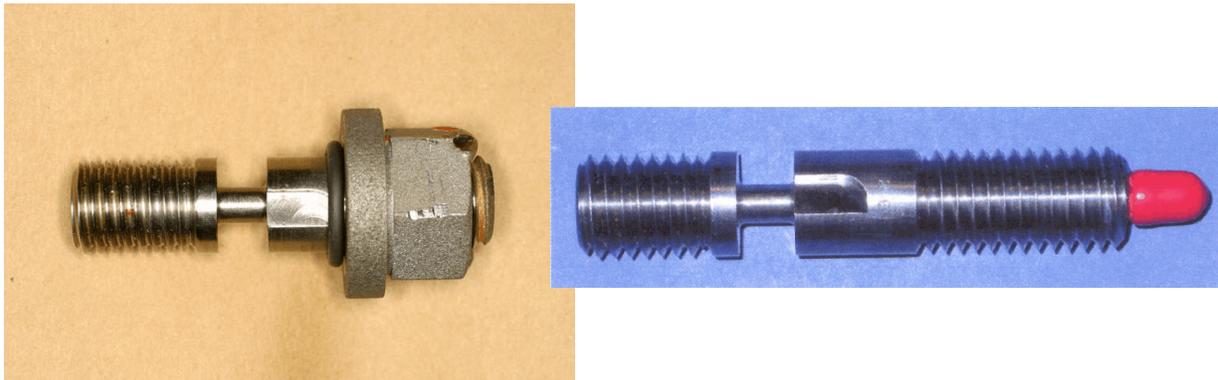
Figure 3a and 3b. The breakaway studs before (left) and after the design modification to include strain gages (right). The red tip covers the strain gage electrical connection.

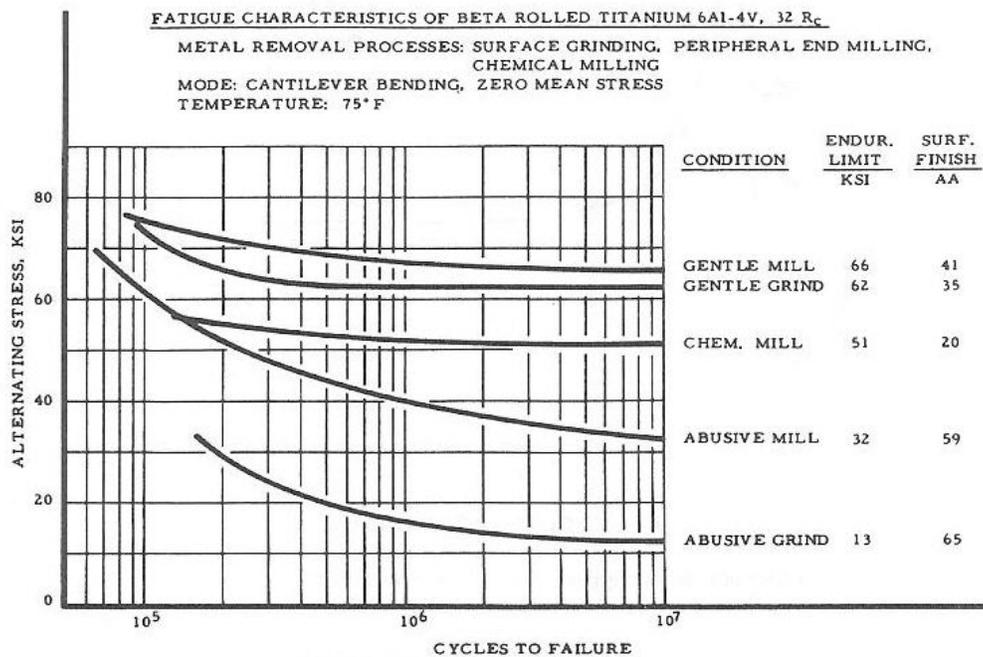
In this case the material is a titanium alloy, Ti -4Al-6V. The surface condition is abusively ground for this material, particularly at transition locations in the reduced section radii (points where the radius changes and stresses are high). A fatigue endurance limit for this condition is 13 ksi as shown in Figure 18 [5]. The fatigue endurance limit is the stress level below which no fatigue damage occurs for no mean stress or preload.

Figure 18. Fatigue characteristics of titanium alloy Ti-6Al-4V [11].

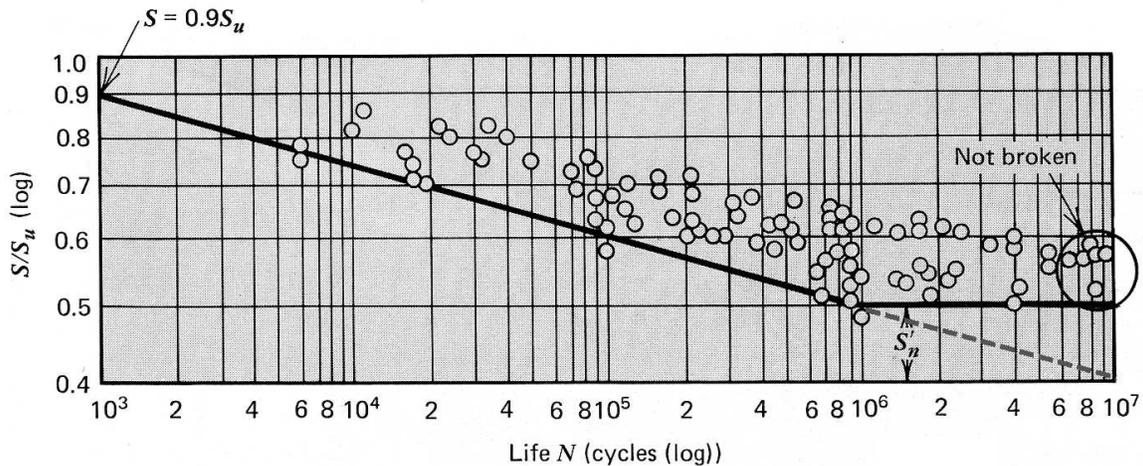
Figure 21. Conceptual fatigue curve [8]. The dashed line represents no endurance limit.
